**MARYLAND HISTORICAL TRUST
DETERMINATION OF ELIGIBILITY FORM**

Property Name: Strawberry Hill Farm Inventory Number: HA-2175
Address: 2815 Calvary Road Historic district: ☐ yes ☒ no
City: Bel Air Zip Code: 21015 County: Harford
USGS Quadrangle(s): Edgewood
Property Owner: Schenning Family Properties LLC Tax Account ID Number: 084135
Tax Map Parcel Number(s): 69 Tax Map Number: 57
Project: Section 200: I-95, North of MD 43 to North of MD 22 Agency: Maryland Transportation Authority
Agency Prepared By: A.D. Marble & Company
Preparer's Name: Emma Young Date Prepared: 9/27/2006
Documentation is presented in: Harford County Office of Land Records, Bel Air, Maryland.
Preparer's Eligibility Recommendation: ☐ Eligibility recommended ☒ Eligibility not recommended
Criteria: ☐ A ☐ B ☐ C ☐ D Considerations: ☐ A ☐ B ☐ C ☐ D ☐ E ☐ F ☐ G
Complete if the property is a contributing or non-contributing resource to a NR district/property:
Name of the District/Property: _____
Inventory Number: _____ Eligible: ☐ yes Listed: ☐ yes

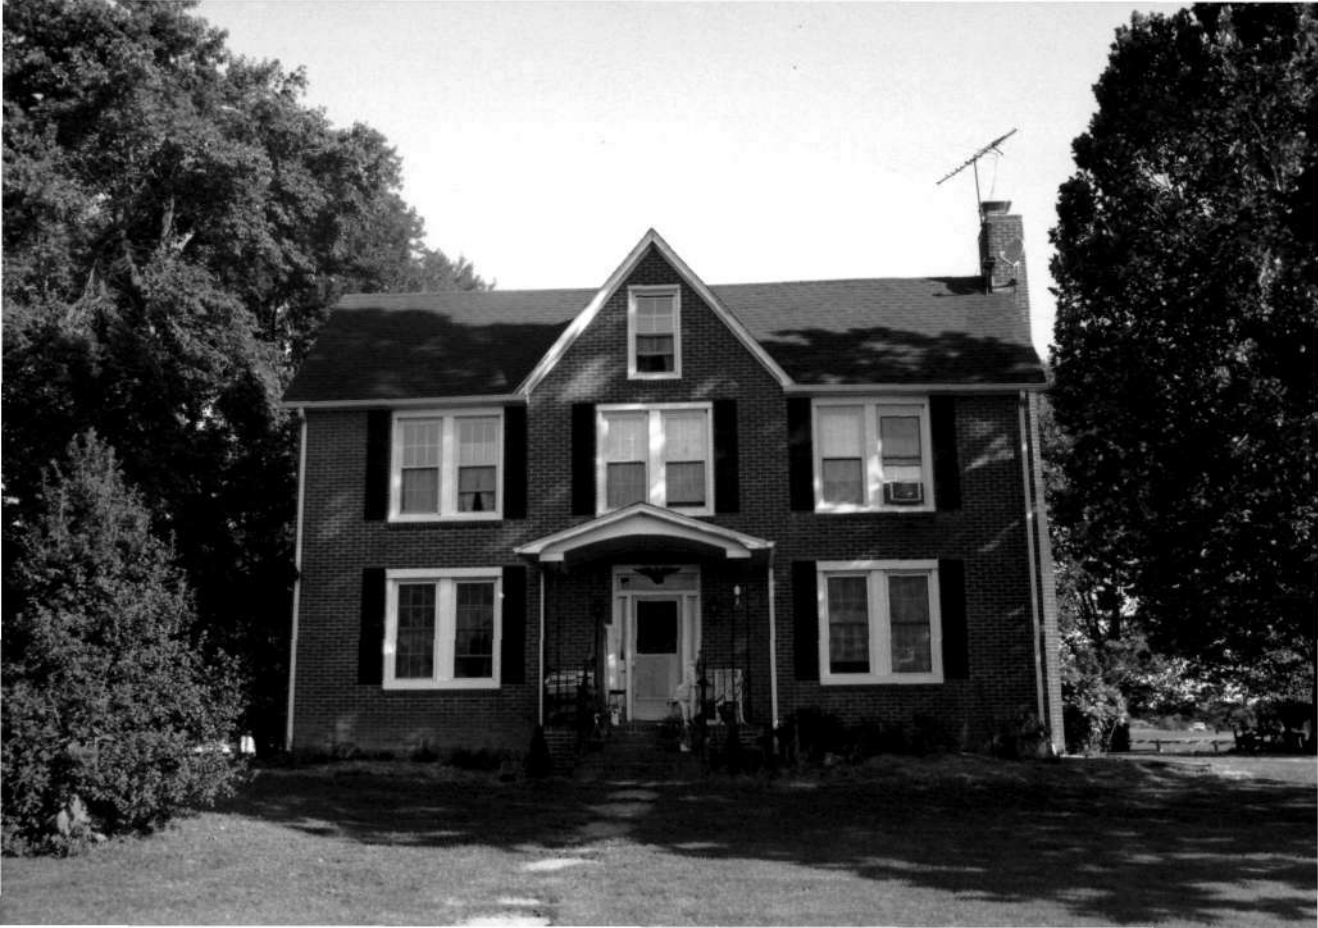
1 of 10

was largely reconstructed, including a replacement brick exterior and replacement windows, circa 1980. The symmetrical façade faces south towards the farm lane. The cross-gable roof, sheathed in asphalt shingles, features an exterior brick chimney on the north elevation. The dwelling contains a modern exterior comprised of brick laid in a bond of continuous running stretchers. The dwelling sits atop a full brick foundation.

The south (front) elevation measures three bays wide. A one-story, one-bay, entry porch shelters the main entry into the dwelling, which occupies the center bay. A pedimented roof, supported by decorative aluminum posts and brackets, caps the porch, which is comprised of a brick landing and a decorative aluminum balustrade. The main entry consists of a single-leaf, wooden, paneled door, complete with a two-light aluminum storm door. A five-light transom tops the doorway. Five sets of paired, six-over-six light, double-hung sash, aluminum, replacement windows are evenly spaced on the south elevation. A pair of inoperable, aluminum, louvered, shutters flanks each opening. A single, four-over-four light, double-hung sash, wooden window is located in the cross gable.

Dwelling - south elevation, view to north

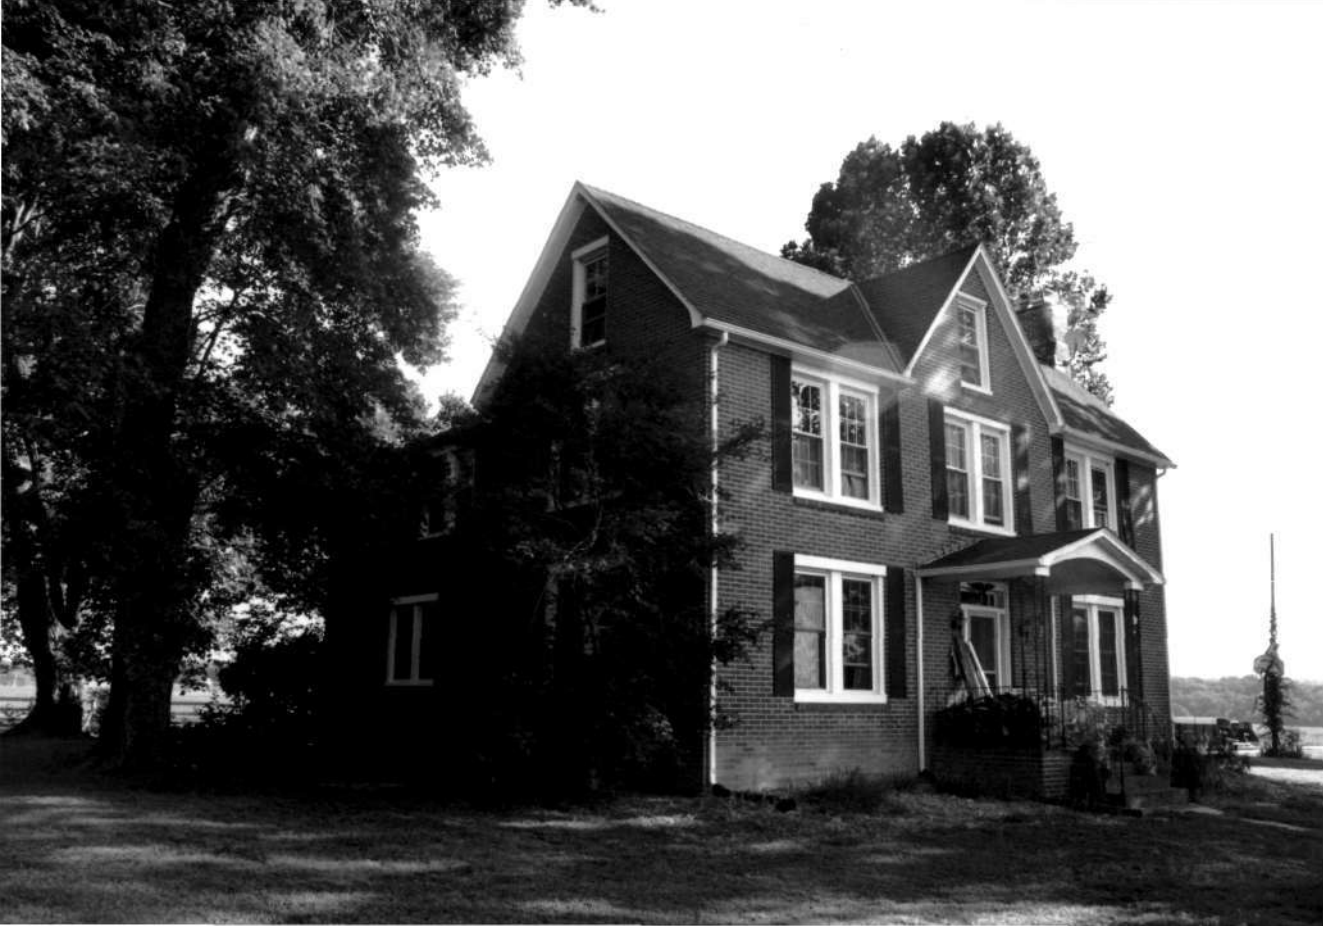
2 of 10

The west elevation features three unevenly spaced bays. The first floor consists of two sets of paired, six-over-six light, double-hung sash, aluminum replacement windows. The second floor contains three sets of paired, six-over-six light, double-hung sash, aluminum replacement windows. An aluminum lintel and sill frames each set of windows. A single, six-over-six light, double-hung sash, wooden window is located in the gable.

Dwelling - south & west elevations; view to NE

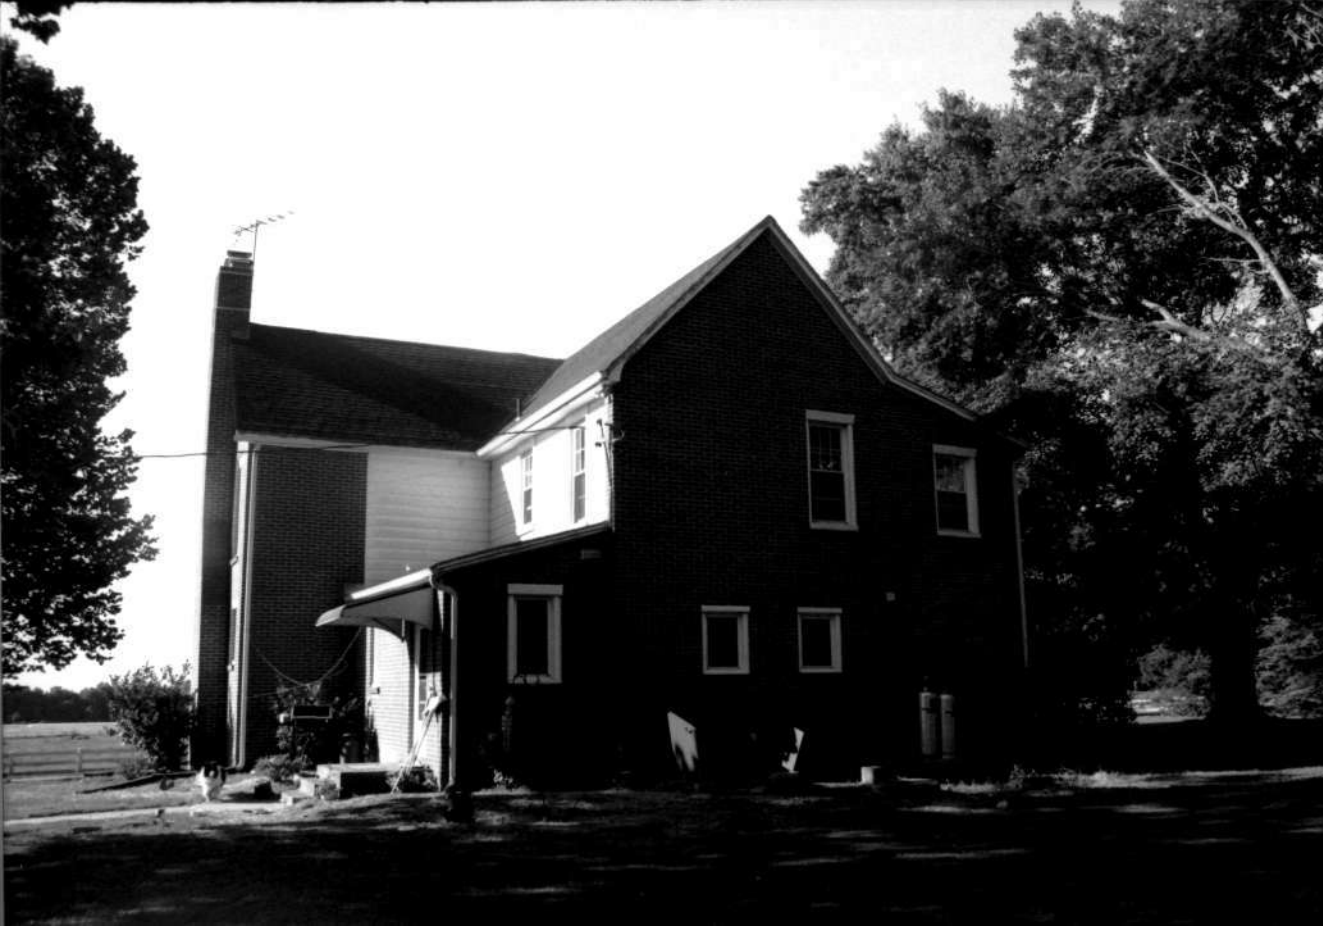
3 of 10

The north (rear) elevation of the dwelling features a two-and-a-half-story, front-gabled ell with a two-story, shed-roof, extension on the west elevation and a one-story, shed-roof extension on the north elevation. The second story of the main block is clad in aluminum siding. The north elevation features an irregular fenestration pattern. A double-leaf, aluminum bulkhead door is located underneath the easternmost bay of the rear ell. Two, one-over-one light, double-hung sash, aluminum windows are located on the first floor. The second floor consists of a six-over-six light, double-hung sash, aluminum window. A single, two-over-two light, double-hung sash, aluminum window occupies the easternmost bay of the one-story shed addition, while a single, three-over-three light, double-hung sash, aluminum window occupies the second story of the two-story shed-roof addition.

Dwelling - north elevation; view to south

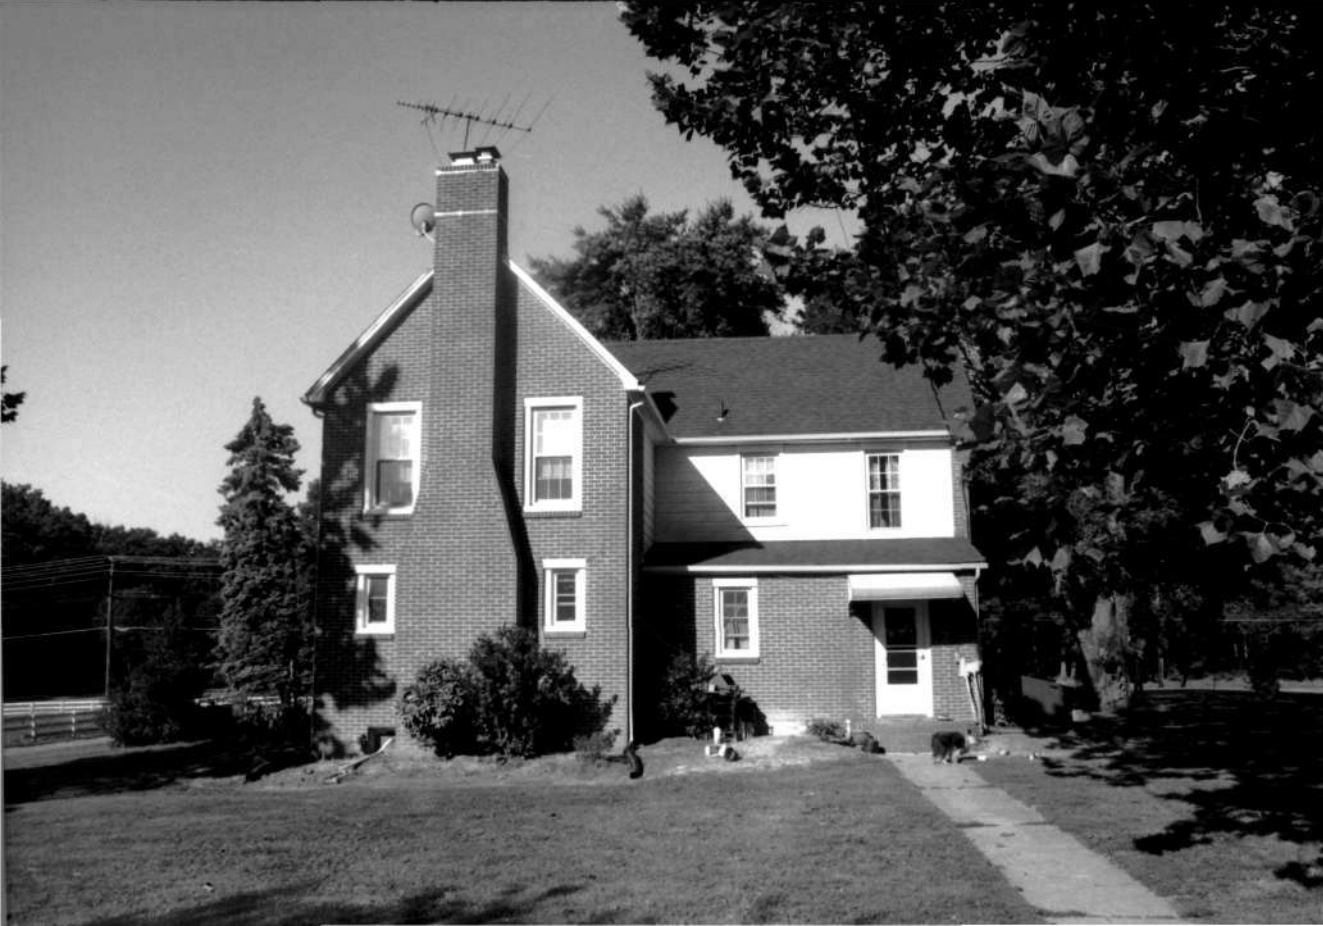
4 of 10

The east elevation contains two evenly spaced bays on the main (south) block and two irregularly spaced bays on the rear ell. The first floor of the main block consists of two, single, one-over-one light, double-hung sash, wooden windows encased within an aluminum surround. The second floor contains two, single, six-over-six light, double-hung sash, aluminum windows. The first floor of the rear ell features a single, two-over-two light, double-hung sash, aluminum window. An aluminum awning shelters the northernmost bay, which contains a secondary entrance comprised of a two-light, aluminum storm door accessed by three brick steps. The second floor of the rear ell, clad in aluminum siding, features two, six-over-six light, double-hung sash, aluminum windows.

Dwelling - east elevation; view to west

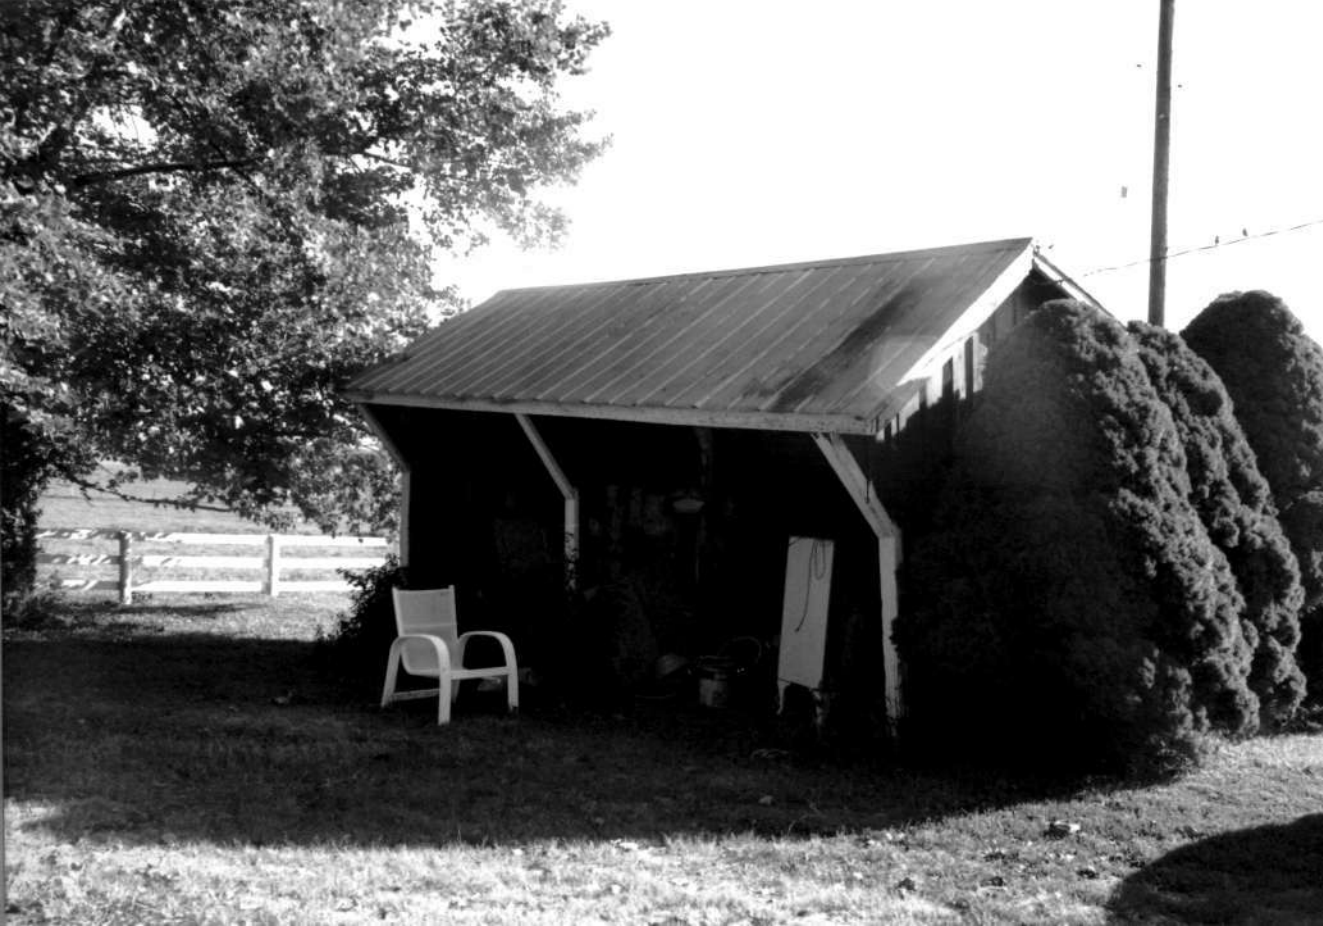
5 of 10

To the northeast of the dwelling sits a one-story, two-bay, circa-1930, frame garage, in fair condition and currently used for storage. The exterior is clad in board-and-batten siding, painted red, and the asymmetrical gable roof is sheathed in standing seam metal. The west (front) elevation features two open bays divided by a wooden post. The north, south, and east elevations are devoid of openings.

garage - south & west elevations; view to NE

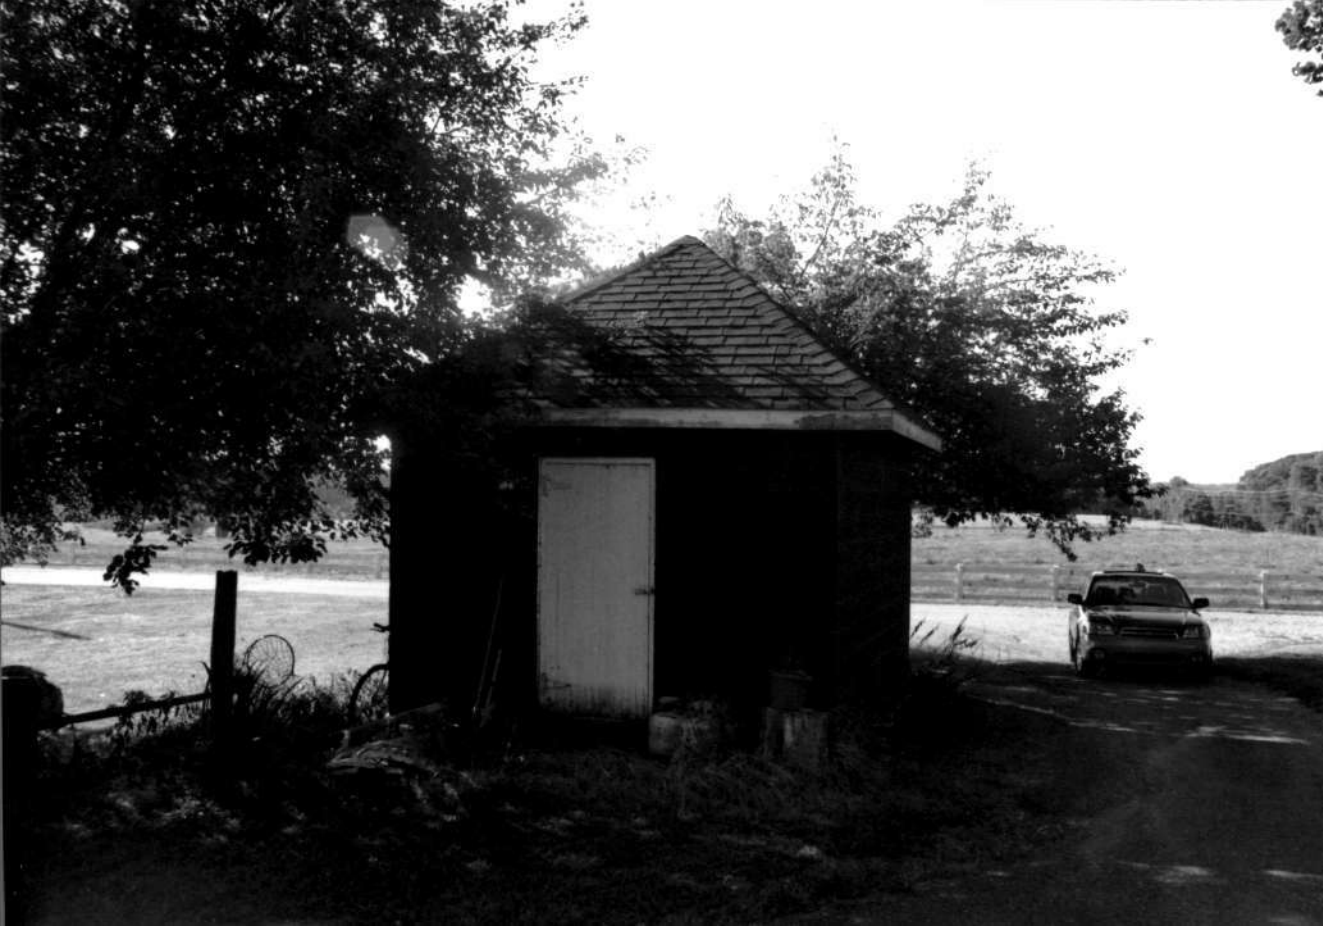
6 of 10

A one-story, one-bay, circa-1940, concrete block milk house, standing in good condition, is located to the south of the garage. A hipped roof, sheathed in asphalt shingles, protects the building. A single-leaf, whitewashed, board and batten door, located on the north elevation, provides the only opening into the milk house.

Milkhouse - north & west elevations; view to SE

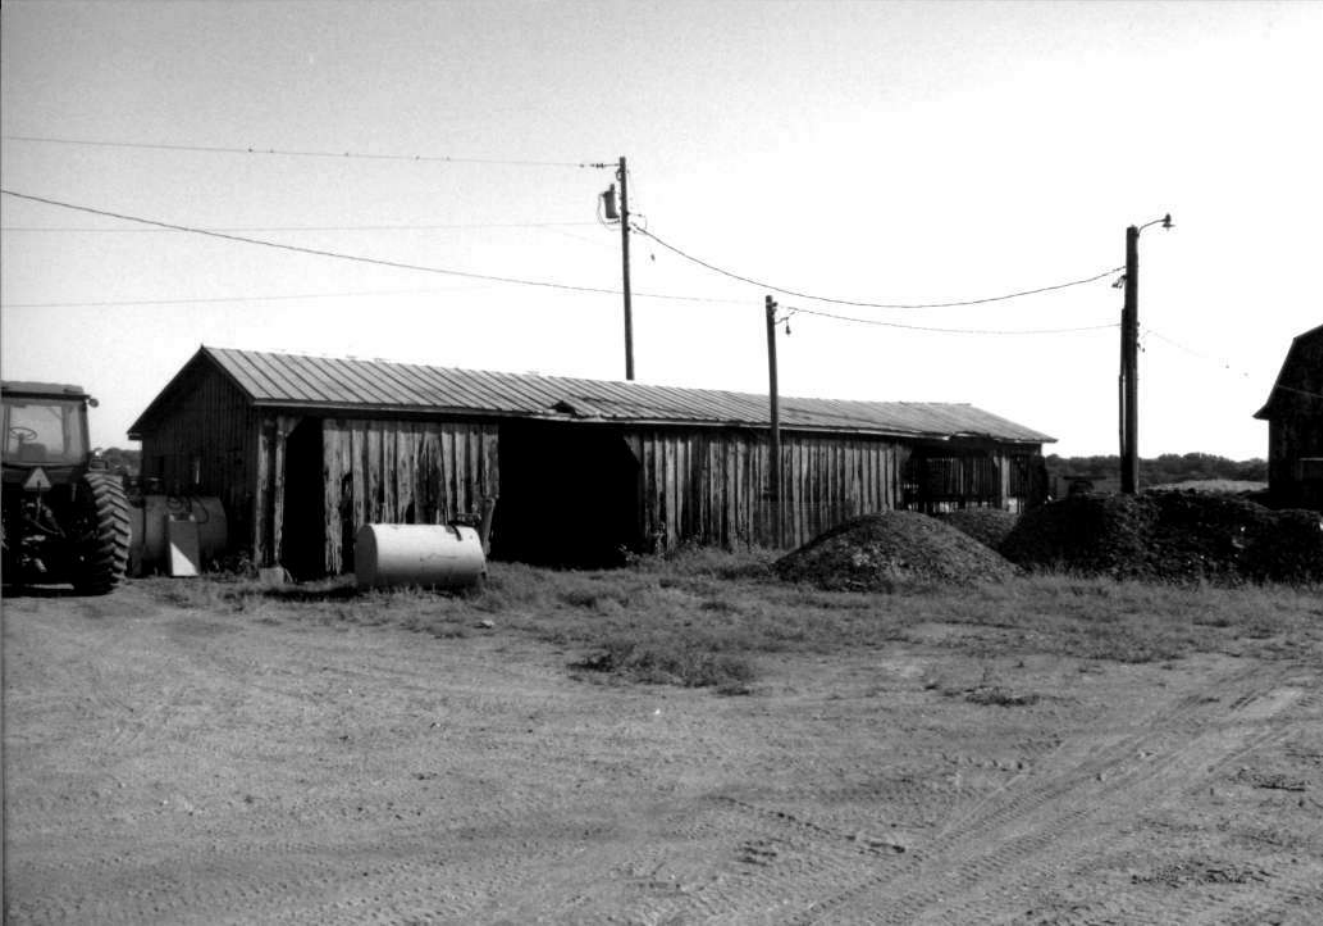
7 of 10

To the east of the milk house sits a one-story, three-bay, circa-1900, frame equipment shed in fair condition. Board and batten siding, with traces of red paint, covers the exterior. An asymmetrical gable roof, clad in standing seam metal, caps the long, rectangular building. The south (front) elevation features three, unevenly spaced openings, concealed with sliding, board and batten, barn doors. A single-leaf, pedestrian entrance, comprised of a board and batten door attached with metal strap hinges, occupies the southernmost bay of the west elevation. Two, evenly spaced, six-light, fixed-sash, wooden windows complete the west elevation. The north and east elevations contain no openings.

Equipment Shed - south & west elevations; view to NE

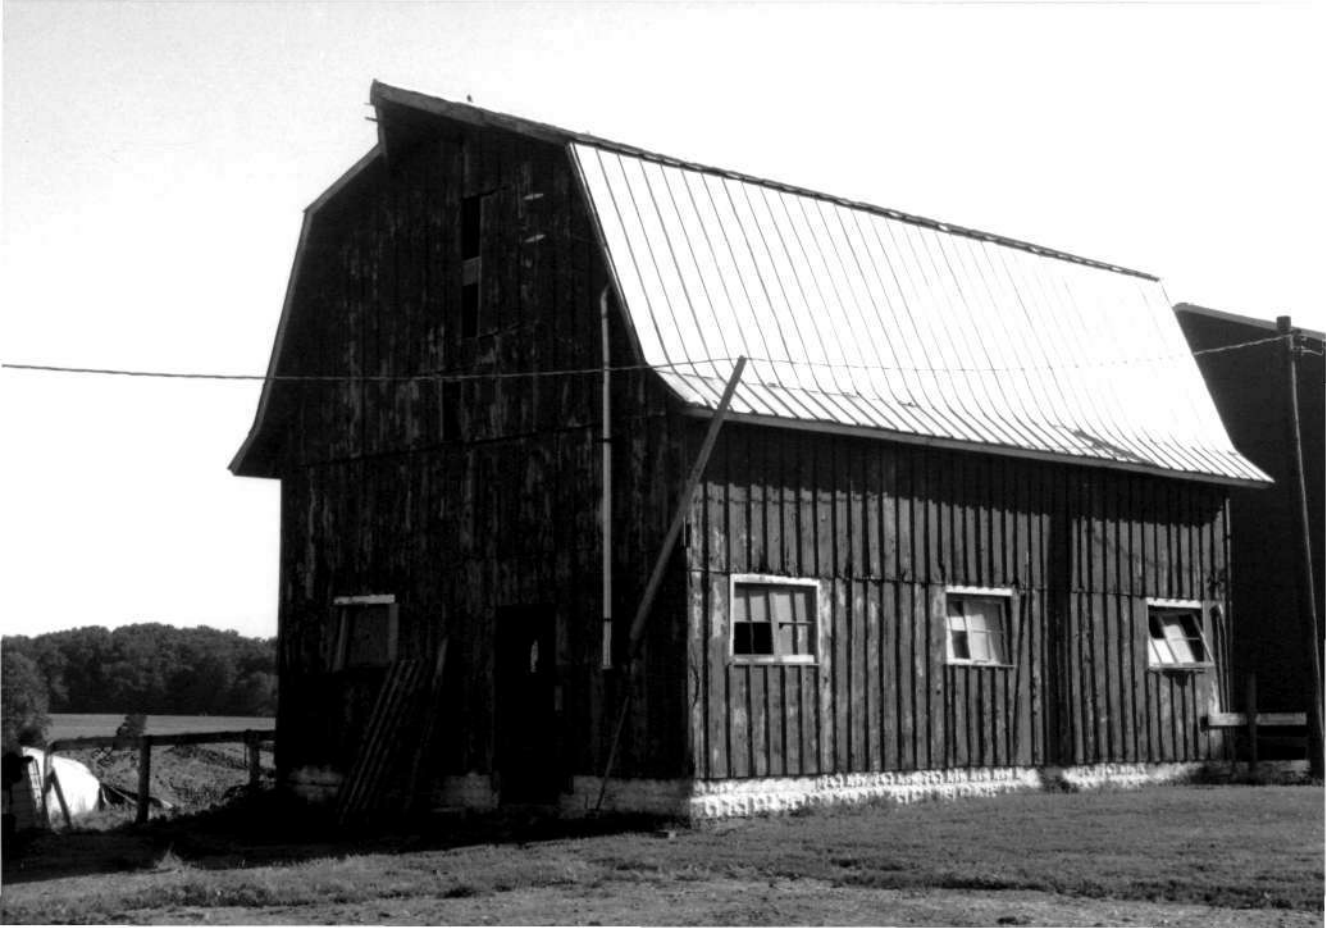
8 of 10

A two-story, circa-1900, frame hay barn, currently used for storage and standing in fair condition, is located to the east of the equipment shed. Board and batten siding, painted red, covers the exterior of the building, which sits atop a rusticated concrete block foundation. The steeply pitched, gambrel roof, clad in standing seam metal and featuring flared eaves and a hay hood, caps the building. A single-leaf, pedestrian entrance is located in the southernmost bay of the west elevation. A square opening, concealed with plywood, occupies the northernmost bay of the west elevation.

Hay Barn - south & west elevations; view to NE

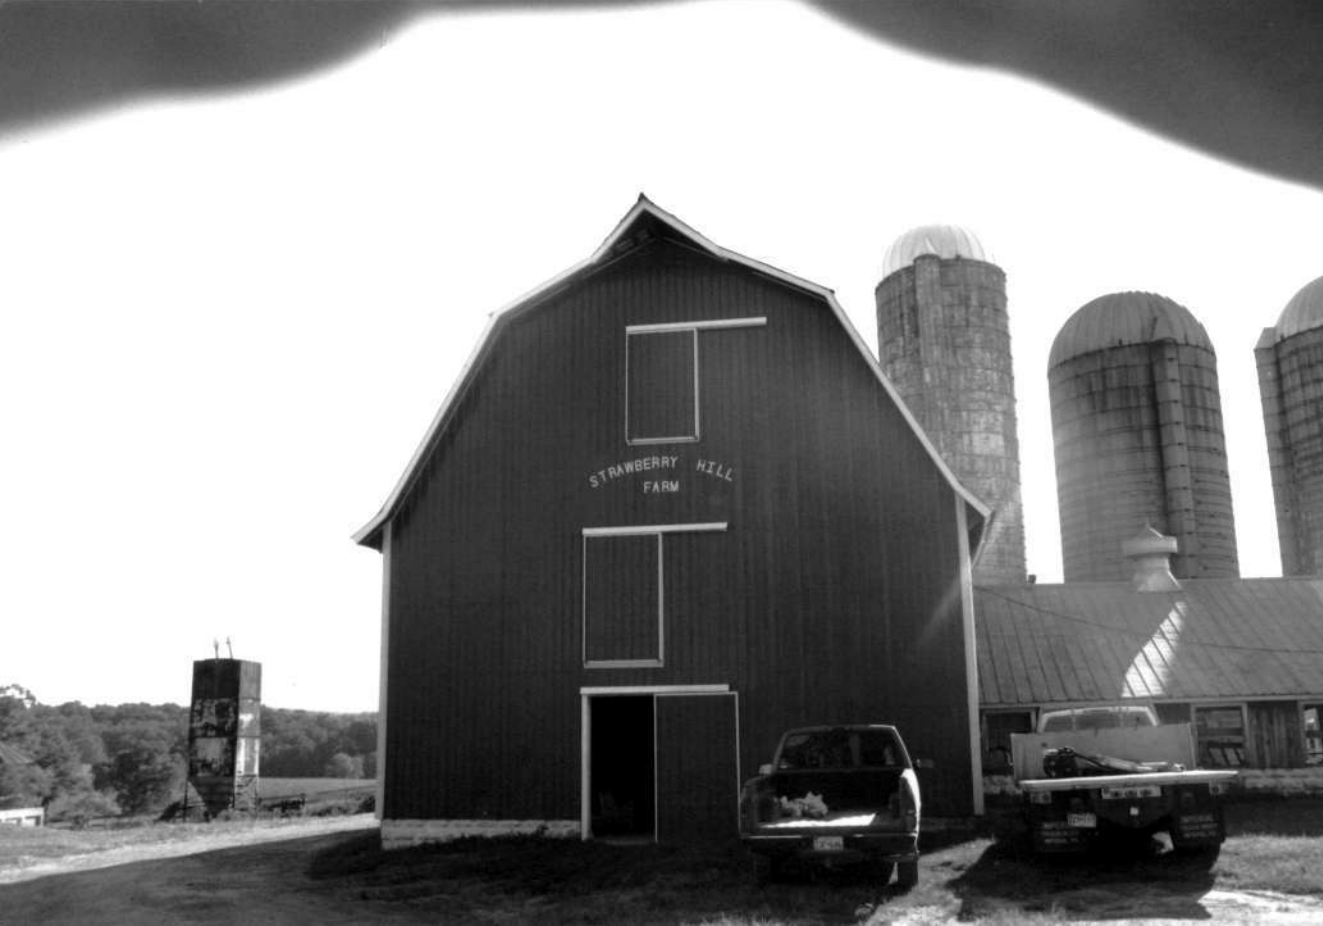
9 of 10

A two-and-a-half-story, circa-1900, frame horse barn, standing in good condition, is located to the east of the hay barn. The exterior of the building was resided in vertical aluminum siding circa 2000. A gambrel roof, sheathed in asphalt shingles and featuring flared eaves, caps the building, which sits atop a rusticated concrete block foundation. The west (front) elevation contains one bay, which consists of a sliding door centrally located on each of the floors. The north, east, and south elevations contain no openings.

Horse Barn - west elevation, view to east

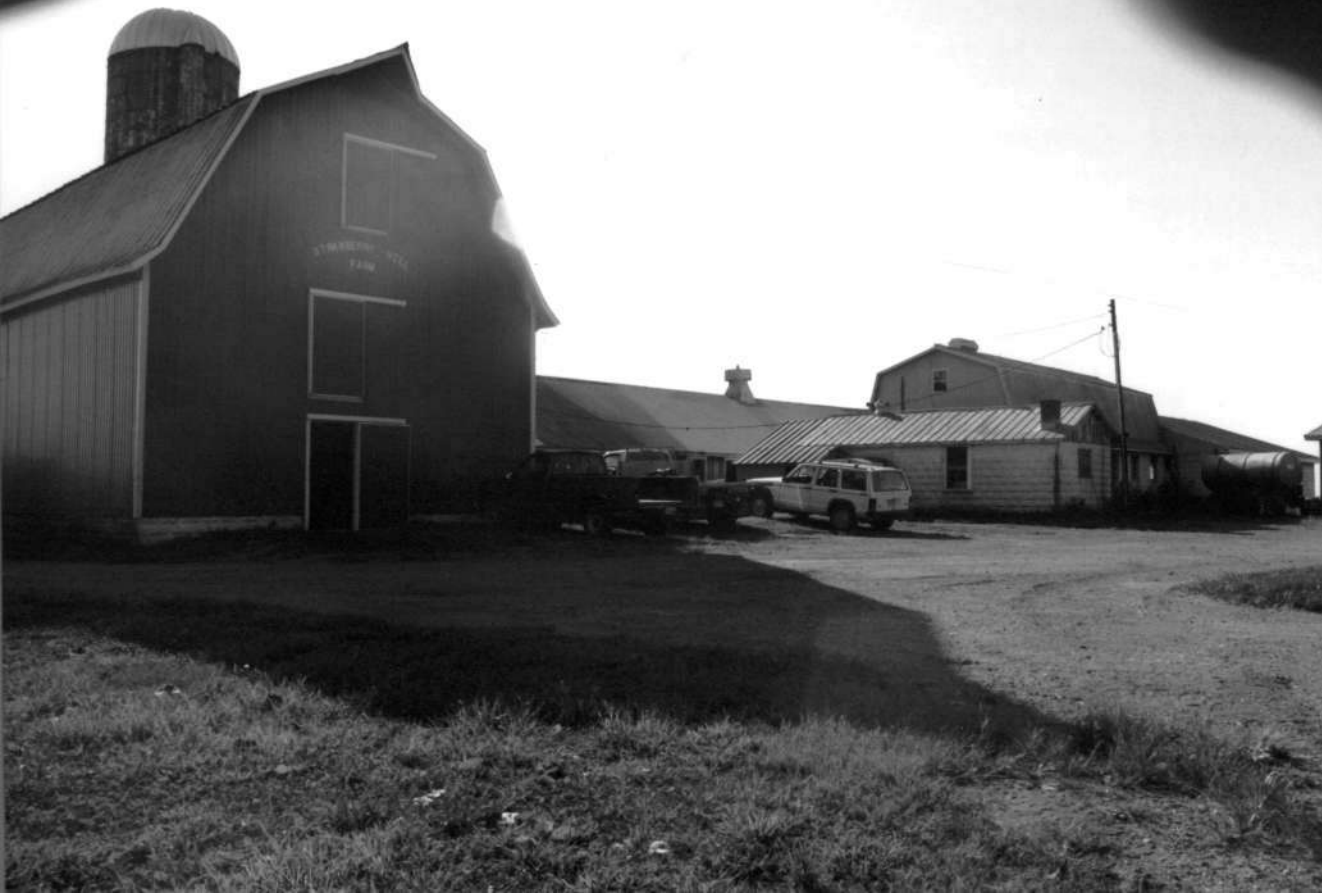
A large dairy complex is located to the southeast of the hay barn. The dairy complex features a two-story, circa-1920, gambrel roof, frame dairy barn in the center. The first floor is comprised of concrete block, while the second floor is sheathed in aluminum siding. A one-story, front-gabled, rectangular, circa-1930, concrete block milk house is attached to the north elevation of the dairy barn; a wide, side-gabled, circa-1930 frame stable is attached to the south side of the dairy barn. The south and east elevations of the stable are completely open. A long, rectangular, circa-1980, side-gabled cow barn, comprised of aluminum siding and concrete block, extends the length of the dairy barn on the eastern side. A one-story, side-gabled, frame shed is attached directly to the south elevation of the cow barn. Overall, the dairy complex stands in good condition.

08, 2006
MD SHPO
Horse Barn & Dairy Complex - view to SE
#10 of 10
